## INTRODUCTION

This information sheet deals with the care and conservation of metals used in building, including cast and wrought iron as fencing and decorative panels, steel-framed windows and roof plumbing. For further information refer to the references at the end of the sheet, and to the separate information sheets on Corrugated Roofing, and Slating, Tiling and Roof Plumbing.

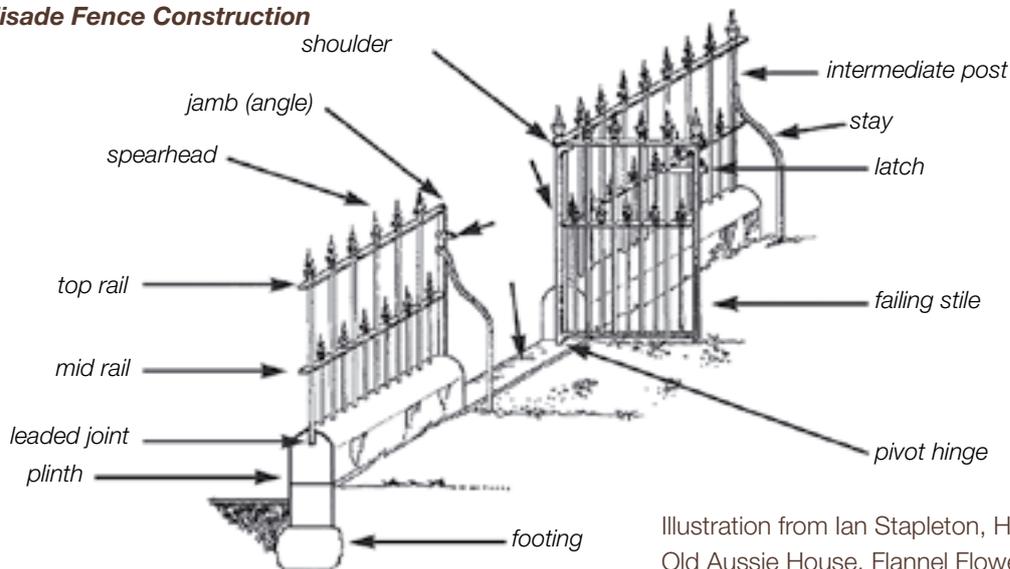
### Iron Palisade Fence Construction

Palisade fences typically have a low stone or rendered brick plinth surmounted by a palisade of wrought iron or mild steel shafts. The shafts penetrate flat wrought iron or mild steel rails and carry ornamental spearheads or tops of cast iron. The iron palisade is supported along its length by posts of cast or wrought iron or masonry.

The traditional practice was to set the iron shafts in a leaded joint by pouring molten lead into an oversize hole around the base of the shaft and tamping it down as it cooled. The lead insulates the iron from damp stone and, because it is soft, allows a certain amount of movement due to thermal expansion and contraction of the iron.

Illustration from Ian Stapleton, *How to Restore the Old Aussie House*, Flannel Flower Press, 1991

Crevice corrosion can occur where the shafts penetrate the rails, and also between the spearheads and the top rail. Careful filling and painting of these areas is required to eliminate crevices where corrosion may occur.

The problem with such fixings is that repeated thermal cycling creates a very small gap between the iron and the lead, allowing water entry and consequent crevice corrosion. Severe corrosion of the iron can result in rupturing of the masonry base as the rusted metal expands.

In order of increasing intervention, conservation approaches to corroded palisade shafts include:

- removing the shafts, treating them for rust, and replacing them according to traditional practice with molten lead;
- removing the shafts, treating them for rust, and replacing them with a modern packing such as expansive tape;
- cutting off the corroded base and welding on a new base of mild steel, galvanising the whole shaft, and resetting it in lead;
- cutting off the corroded base and welding on a new base of stainless steel, which is then set in lead or in expansive tape. If lead is used it will be the less noble metal and will therefore corrode;
- cutting off the corroded base to a stump and fastening a new base of stainless steel tubing over the stump using epoxy adhesives. The outside diameter of the tubing must match that of the shaft. The tubing can then be set in lead or in expansive tape;
- replacing the entire palisade in new galvanised steel painted an appropriate colour.
